**Federal Highway
Administration**

This letter is in response to your March 13, 2019 request for the Federal Highway Administration (FHWA) to review a roadside safety device, hardware, or system for eligibility for reimbursement under the Federal-aid highway program. This FHWA letter of eligibility is assigned FHWA control number CC-155 and is valid until a subsequent letter is issued by FHWA that expressly references this device.

- SLED to MGS Guardrail

Name of system: SLED to MGS Guardrail
Type of system: Crash Cushion
Test Level: MASH Test Level 3 (TL3)
Testing conducted by: KARCO
Date of request: March 13, 2019

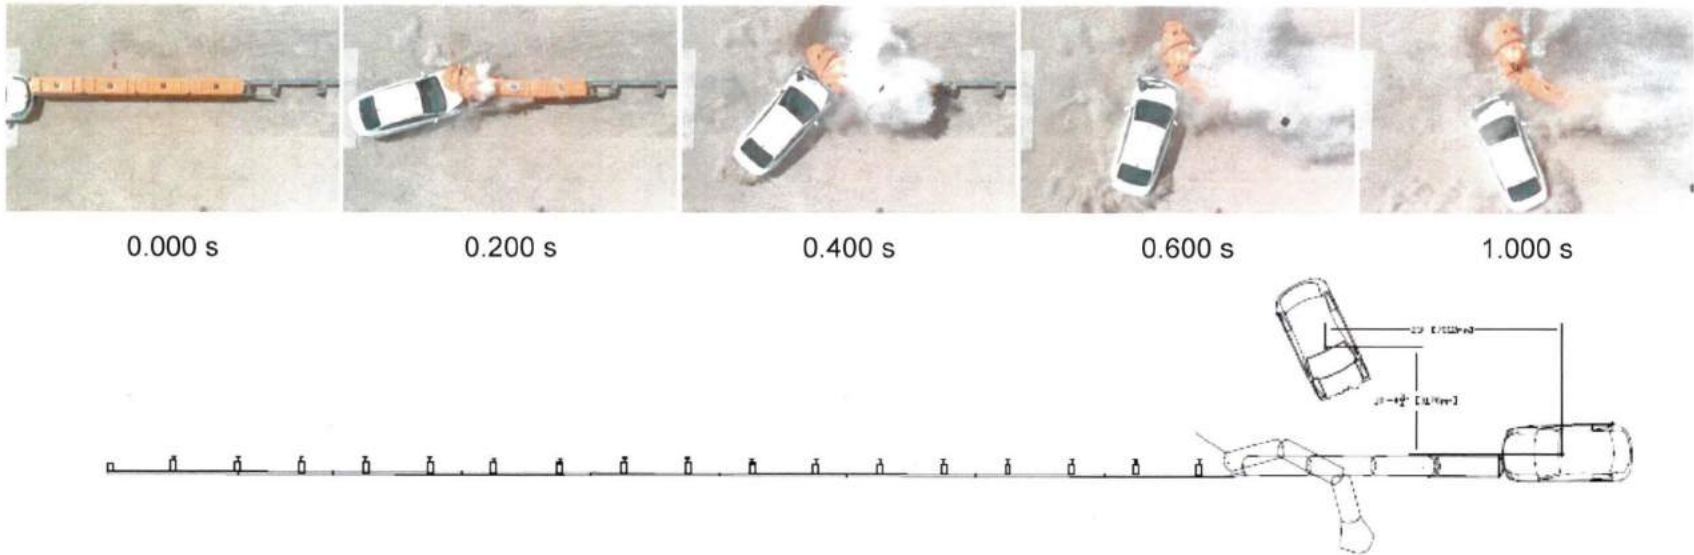
Figure 2 Summary of Test 3-40

General Information	
Test Agency.....	KARCO Engineering, LLC.
KARCO Test No.....	P37262-01
Test Designation.....	3-40
Test Date.....	07/23/17
Test Article	
Name / Model.....	SLED Attached to Guardrail
Type.....	Crash Cushion
Article Length.....	25.0 ft. (7.6 m)
Installation Length.....	136.1 ft. (41.5 m)
Road Surface.....	Medium to Fine Silty Soil
Test Vehicle	
Type / Designation.....	1100C
Year, Make, and Model.....	2013 Kia Rio
Curb Mass.....	2,554.0 lbs (1,158.5 kg)
Test Inertial Mass.....	2,471.3 lbs (1,121.0 kg)
Gross Static Mass.....	2,627.9 lbs (1,192.0 kg)

Impact Conditions	
Impact Velocity.....	62.78 mph (101.03 km/h)
Impact Angle.....	0.5°
Location / Orientation.....	Offset 16.8 in. (428 mm)
Kinetic Energy.....	325.6 kip-ft (441.5 kJ)
Exit Conditions	
Exit Velocity.....	N/A
Exit Angle.....	N/A
Final Vehicle Position.....	23.0 ft. (7.0 m) downstream
	10.4 ft. (3.2 m) right
Vehicle Snagging.....	None
Vehicle Pocketing.....	None
Vehicle Stability.....	Satisfactory
Maximum Roll Angle.....	-8.1°
Maximum Pitch Angle.....	5.2°
Maximum Yaw Angle.....	-113.7°

Occupant Risk	
Longitudinal OIV.....	10.6 m/s (34.8 ft/s)
Lateral OIV.....	0.3 m/s (1.0 ft/s)
Longitudinal RA.....	-18.6 g
Lateral RA.....	-1.8 g
THIV.....	10.5 m/s (34.4 ft/s)
PHD.....	18.2 g
ASI.....	1.18
Test Article Deflections	
Static.....	7.2 ft. (2.2 m)
Dynamic.....	7.2 ft. (2.2 m)
Working Width.....	9.4 ft. (2.9 m)
Debris Field.....	65.9 ft. (20.0 m) downstream
	24.3 ft. (7.4 m) right
Vehicle Damage	
Vehicle Damage Scale.....	12-FD-4
CDC.....	12FDEW4
Maximum Intrusion.....	0.8 in. (19 mm)

Required Test Number	Narrative Description	Evaluation Results
3-40 (1100C)	<p>The SLED was positioned offset a quarter of the vehicle's width towards the passenger side. The offset position examines the risk of exceeding occupant risk values, vehicle instability, and vehicle yaw movement. The test was conducted using a commercially available 2013 Kia Rio 4-door sedan with a test inertial mass of 2,471.3 lbs. (1,121.0 kg). The test vehicle impacted the SLED at a velocity of 62.78 mph (101.03 km/h) and at an impact angle of 0.5°. The test vehicle impacted the steel Containment Impact Sled (CIS), pushing it rearward crushing and rupturing the yellow empty module within the CIS. As the vehicle continued downstream the three yellow water filled modules were crushed, ruptured, and dispersed the contained water. The vehicle rotated in a counter clockwise direction about its yaw axis before coming to a controlled stop 23.0 ft. (7.0 m) forward and 10.4 ft. (3.2 m) lateral from the initial point of impact. The yellow SLED modules remained tethered together and securely attached to the guardrail via the steel t-pins between the module knuckles which connects directly to the internal molded in steel cables. The impacting vehicle was brought to a controlled stop, remained upright and did not exhibit vaulting throughout the impact event. The test vehicle's occupant compartment was not penetrated and there was no in cab deformation beyond allowable limits. The maximum roll and pitch angle did not exceed 75° and occupant risk values were within limits per MASH specifications for Occupant Impact Velocity (OIV) and Ridedown Acceleration (RA). The SLED attached to guardrail met all the requirements of MASH Test 3-40.</p>	PASS

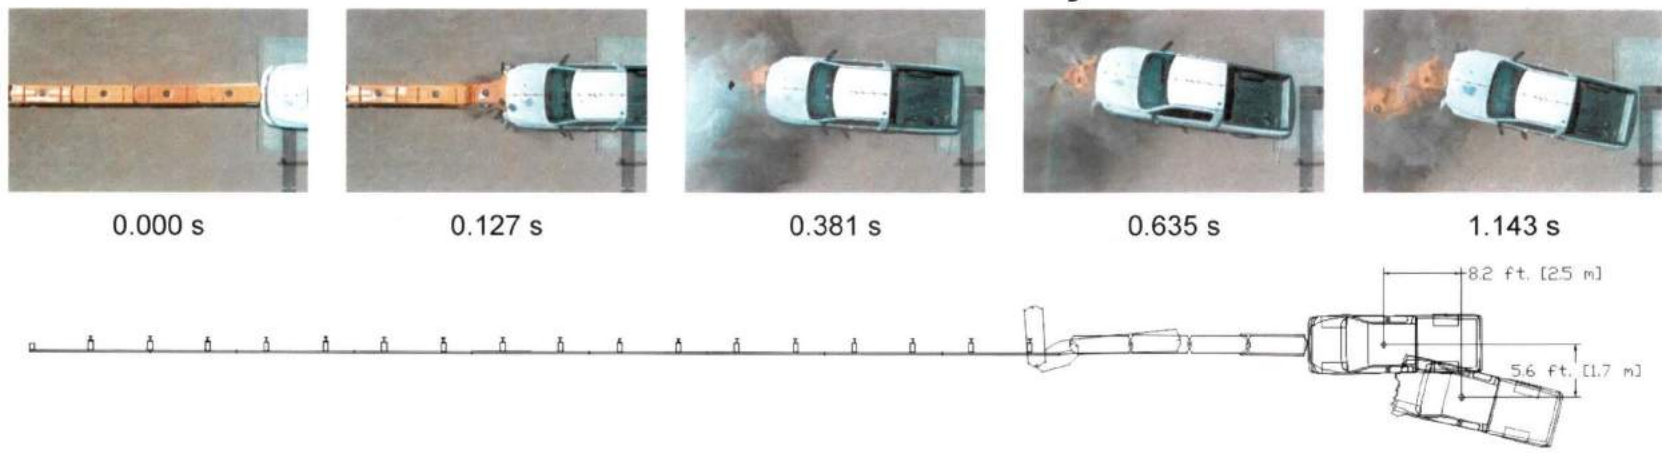
Figure 2 Summary of Test 3-41

General Information	
Test Agency.....	IDIADA KARCO
KARCO Test No.....	P37165-01
Test Designation.....	3-41
Test Date.....	06/06/17
Test Article	
Name / Model.....	SLED Attached to GR
Type.....	Non-redirective Crash Cushion
Article Length.....	25.3 ft. (7.7 m)
Installation Length.....	131.4 (40.1 m)
Road Surface.....	Medium to Fine Silty Soil
Test Vehicle	
Type / Designation.....	2270P
Year, Make, and Model.....	2013 Ram 1500
Curb Mass.....	4,888.7 lbs (2,217.5 kg)
Test Inertial Mass.....	4,986.8 lbs (2,262.0 kg)
Gross Static Mass.....	4,986.8 lbs (2,262.0 kg)

Impact Conditions	
Impact Velocity.....	62.75 mph (100.99 km/h)
Impact Angle.....	0.6°
Location / Orientation.....	Center vehicle to center of CC
Kinetic Energy.....	656.5 kip-ft (890.0 kJ)
Exit Conditions	
Exit Velocity.....	N/A
Exit Angle.....	N/A
Final Vehicle Position.....	8.2 ft. (2.5 m) Rearward
	5.6 ft. (1.7 m) Left
Vehicle Snagging.....	None
Vehicle Pocketing.....	None
Vehicle Stability.....	Satisfactory
Maximum Roll Angle.....	20.8 °
Maximum Pitch Angle.....	-12.0 °
Maximum Yaw Angle.....	5.6 °

Occupant Risk	
Longitudinal OIV.....	11.2 m/s (36.7 ft/s)
Lateral OIV.....	0.3 m/s (1.0 ft/s)
Longitudinal RA.....	-11.5 g
Lateral RA.....	1.2 g
THIV.....	11.2 m/s (36.7 ft/s)
PHD.....	10.8 g
ASI.....	1.13
Test Article Deflections	
Static.....	1.6 ft. (0.5 m)
Dynamic.....	1.6 ft. (0.5 m)
Working Width.....	10.7 ft. (3.3 m)
Debris Field.....	N/A
Vehicle Damage	
Vehicle Damage Scale.....	12-FC-6
CDC.....	12FDEW2
Maximum Intrusion.....	0.4 in. (10 mm)

3-41 (2270P)	<p>The SLED was positioned in line with the center of the test vehicle. The inline centered position examines the risk of exceeding occupant risk values, vehicle instability, capacity to absorb sufficient kinetic energy, and the SLED's ability to bring the vehicle to a controlled stop. The test was conducted using a commercially available 2013 RAM 1500 4-door pickup truck with a test inertial mass of 4,986.8 lbs. (2,262.0 kg). The test vehicle impacted the SLED at a velocity of 62.75 mph (100.99 km/h) and at an impact angle of 0.6°. The test vehicle impacted the steel Containment Impact Sled (CIS), pushing it rearward crushing the yellow empty module within the CIS. As the vehicle continued downstream the three yellow water filled modules were crushed, ruptured, and dispersed the contained water. The yellow SLED modules remained tethered together and securely attached to the guardrail via the steel t-pins between the module knuckles which connects directly to the internal molded in steel cables. The impacting vehicle was brought to a stop 8.2 ft. (2.5 m) rearward and 5.6 ft. (1.7 m) lateral from the initial point of impact, remained upright and did not exhibit vaulting throughout the impact event. The test vehicle's occupant compartment was not penetrated and there was no in cab deformation beyond allowable limits. The maximum roll and pitch angle did not exceed 75° and occupant risk values were within limits per MASH specifications for Occupant Impact Velocity (OIV) and Ridedown Acceleration (RA). The SLED attached to guardrail met all the requirements of MASH Test 3-41.</p>	PASS

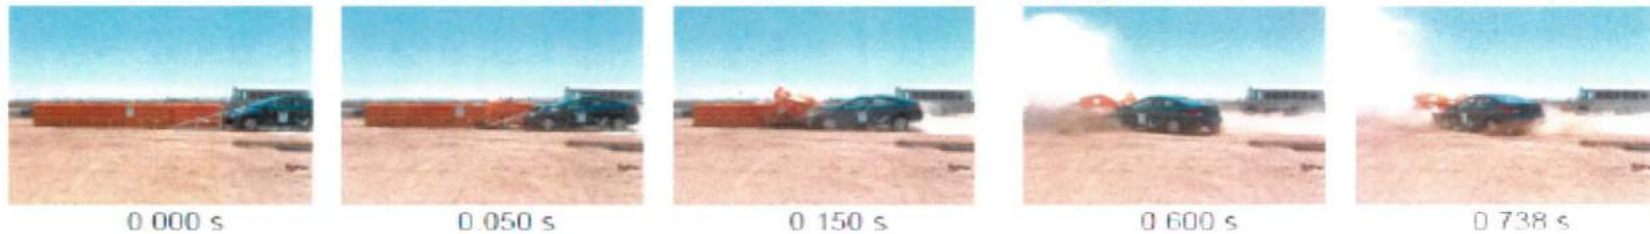
Figure 2 Summary of Test 3-42

General Information	
Test Agency.....	IDIADA KARCO
Test No.....	P38130-01
Test Designation.....	3-42
Test Date.....	05/18/18
Test Article	
Name / Model	SLED Attached to Guardrail
Type	Non-Redirective Crash Cushion
Article Length	25.0 ft (7.6 m)
Installation Length	136.1 ft (41.5 m)
Road Surface.....	Compacted Soil
Test Vehicle	
Type / Designation.....	1100C
Year, Make, and Model.....	2016 Hyundai Accent
Curb Mass.....	2,451.5 lbs (1,112.0 kg)
Test Inertial Mass.....	2,426.1 lbs (1,100.5 kg)
Gross Static Mass.....	2,588.2 lbs (1,174.0 kg)

Impact Conditions	
Impact Velocity.....	61.99 mph (99.76 km/h)
Impact Angle.....	4.2°
Location / Orientation.....	Center of CIS
Kinetic Energy.....	311.7 kip-ft (422.6 kJ)
Exit Conditions	
Exit Velocity.....	N/A
Exit Angle.....	N/A
Final Vehicle Position.....	15.7 ft (4.8 m) downstream
	5.8 ft (1.8 m) Left
Exit Box Criteria Met.....	N/A
Vehicle Snagging.....	None
Vehicle Pocketing.....	None
Vehicle Stability.....	Satisfactory
Maximum Roll Angle.....	7.7°
Maximum Pitch Angle.....	-5.0°
Maximum Yaw Angle.....	51.3°

Occupant Risk	
Longitudinal OIV.....	33.8 ft/s (10.3 m/s)
Lateral OIV.....	1.0 ft/s (0.3 m/s)
Longitudinal RA.....	-19.5 g
Lateral RA.....	-4.8 g
THIV.....	33.8 ft/s (10.3 m/s)
PHD.....	18.9 g
ASI.....	1.20
Test Article Deflections	
Static.....	0.7 ft (0.2 m)
Dynamic.....	5.4 ft (1.6 m)
Working Width.....	11.1 ft (3.4 m)
Debris Field.....	25.5 ft (26.0 m) downstream
	34.8 ft (10.6 m) Left
Vehicle Damage	
Vehicle Damage Scale.....	12-FD-4
CDC.....	12FDEW4
Maximum Intrusion.....	0.1 in. (3 mm)

3-42 (1100C)	<p>The SLED was positioned at a nominal angle of 5° with the centerline of the test vehicle aligned with the nose of the system. The angled position examines the risk of exceeding occupant risk values, vehicle instability, capacity to absorb sufficient impact energy, and the SLED's ability to bring the vehicle to a controlled stop. The test was conducted using a commercially available 2016 Hyundai Accent 4-door sedan with a test inertial mass of 2,426.1 lbs. (1,100.5 kg). The test vehicle impacted the SLED at a velocity of 61.99 mph (99.76 km/h) and at an impact angle of 4.2°. The test vehicle impacted the steel Containment Impact Sled (CIS), pushing it downstream crushing and rupturing the yellow empty module within the CIS. As the vehicle continued downstream the three yellow water filled modules were crushed, ruptured, and dispersed the contained water. The vehicle rotated in a clockwise direction about its yaw axis before coming to a controlled stop 15.7 ft. (4.8 m) downstream and 5.8 ft. (1.8 m) lateral from the initial point of impact. The yellow SLED modules remained tethered together and securely attached to the guardrail via the steel t-pins between the module knuckles which connects directly to the internal molded in steel cables. The impacting vehicle was brought to a controlled stop, remained upright and did not exhibit vaulting throughout the impact event. The test vehicle's occupant compartment was not penetrated and there was no in cab deformation beyond allowable limits. The maximum roll and pitch angle did not exceed 75° and occupant risk values were within limits per MASH specifications for Occupant Impact Velocity (OIV) and Ridedown Acceleration (RA). The SLED attached to guardrail met all the requirements of MASH Test 3-42.</p>	PASS

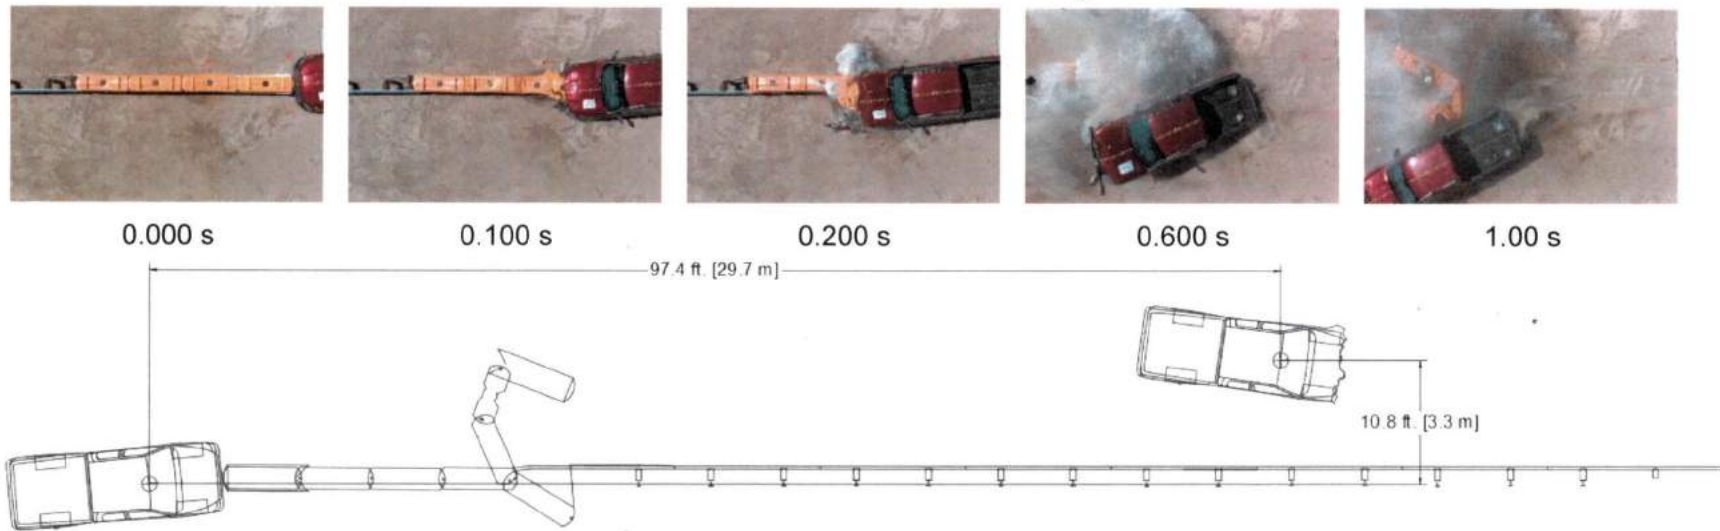
Figure 2 Summary of Test 3-43

General Information	
Test Agency.....	IDIADA KARCO
Test No.....	P38132-01
Test Designation.....	3-43
Test Date.....	05/24/18
Test Article	
Name / Model.....	SLED Attached to GR
Type.....	Non-Redirective Crash Cushion
Article Length.....	25.3 ft. (7.7 m)
Installation Length.....	131.4 ft. (40.1 m)
Road Surface.....	Compacted Soil
Test Vehicle	
Type / Designation.....	2270P
Year, Make, and Model.....	2013 RAM 1500
Curb Mass.....	4,883.2 lbs (2,215.0 kg)
Test Inertial Mass.....	5,003.3 lbs (2,269.5 kg)
Gross Static Mass.....	5,003.3 lbs (2,269.5 kg)

Impact Conditions	
Impact Velocity.....	63.22 mph (101.75 km/h)
Impact Angle.....	5.4°
Location / Orientation.....	Center of CIS
Kinetic Energy.....	668.5 kip-ft (906.4 kJ)
Exit Conditions	
Exit Velocity.....	14.04 mph (22.60 km/h)
Exit Angle.....	11.2°
Final Vehicle Position.....	97.4 ft. (29.7 m) dw
	10.8 ft. (3.3 m) Left
Vehicle Snagging.....	None
Vehicle Pocketing.....	None
Vehicle Stability.....	Satisfactory
Maximum Roll Angle.....	8.8°
Maximum Pitch Angle.....	23.8°
Maximum Yaw Angle.....	-22.9°

Occupant Risk	
Longitudinal OIV.....	32.2 ft/s (9.8 m/s)
Lateral OIV.....	2.6 ft/s (0.8 m/s)
Longitudinal RA.....	-12.8 g
Lateral RA.....	-3.9 g
THIV.....	32.2 ft/s (9.8 m/s)
PHD.....	12.0 g
ASI.....	0.88
Test Article Deflections	
Static.....	7.8 ft. (2.4 m)
Dynamic.....	8.2 ft. (2.5 m)
Working Width.....	16.4 ft. (5.0 m)
Debris Field.....	110.9 ft. (33.8 m) downstream
	29.8 ft. (9.1 m) Left
Vehicle Damage	
Vehicle Damage Scale.....	12-FD-4
CDC.....	12FDEW4
Maximum Intrusion.....	0.2 in. (6 mm)

3-43 (2270P)	<p>The SLED was positioned at a nominal angle of 5° with the centerline of the test vehicle aligned with the nose of the system. The angled position examines the risk of exceeding occupant risk values, vehicle instability, capacity to absorb sufficient impact energy, and the SLED's ability to bring the vehicle to a controlled stop. The test was conducted using a commercially available 2013 RAM 1500 4-door pickup truck with a test inertial mass of 5,003.3 lbs. (2,269.5 kg). The test vehicle impacted the crash cushion at a velocity of 63.22 mph (101.75 km/h) and at an impact angle of 5.4°. The test vehicle impacted the steel Containment Impact Sled (CIS), pushing it rearward crushing and rupturing the yellow empty module within the CIS. As the vehicle continued rearward the three yellow water filled modules were crushed, ruptured, and dispersed the contained water. The vehicle rotated in a clockwise direction about its yaw axis before coming to a controlled stop 97.4 ft. (29.7 m) forward and 10.8 ft. (3.3 m) lateral from the initial point of impact. The yellow SLED modules remained tethered together and securely attached to the guardrail via the steel t-pins between the module knuckles which connects directly to the internal molded in steel cables. The impacting vehicle was brought to a controlled stop, remained upright and did not exhibit vaulting throughout the impact event. The test vehicle's occupant compartment was not penetrated and there was no in cab deformation beyond allowable limits. The maximum roll and pitch angle did not exceed 75° and occupant risk values were within limits per MASH specifications for Occupant Impact Velocity (OIV) and Ridedown Acceleration (RA). The SLED attached to guardrail met all the requirements of MASH Test 3-43.</p>	PASS

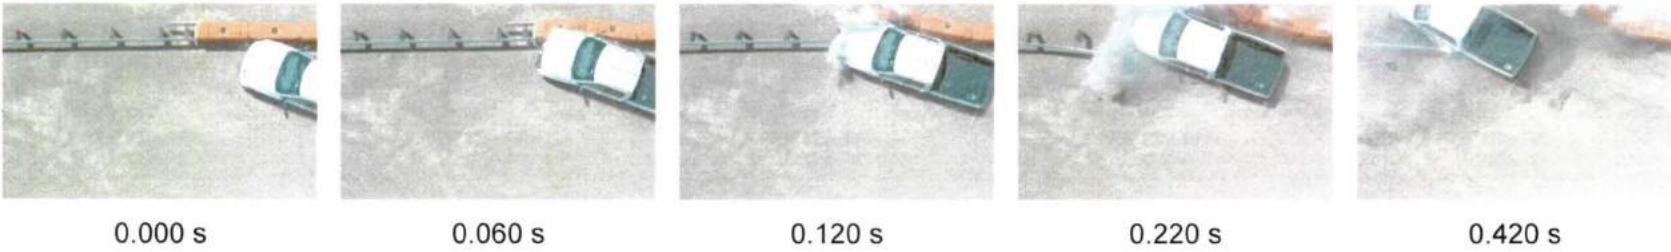
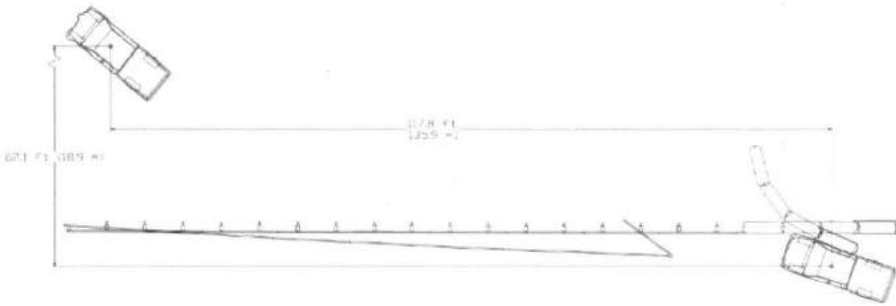
Figure 2 Summary of Test 3-44

General Information	
Test Agency.....	IDIADA KARCO
Test No.....	P37261-01
Test Designation.....	3-44
Test Date.....	07/26/17
Test Article	
Name / Model.....	SLED Attached to GR
Type.....	Non-Redirective Crash Cushion
Article Length.....	25.3 ft. (7.7 m)
Installation Length.....	131.4 ft. (40.1 m)
Road Surface.....	Compacted Soil
Test Vehicle	
Type / Designation.....	2270P
Year, Make, and Model.....	2012 RAM 1500
Curb Mass.....	4,990.1 lbs (2,263.5 kg)
Test Inertial Mass.....	4,989.0 lbs (2,263.0 kg)
Gross Static Mass.....	4,989.0 lbs (2,263.0 kg)

Impact Conditions	
Impact Velocity.....	62.38 mph (100.39 km/h)
Impact Angle.....	19.8°
Location / Orientation.....	Veh. CL to W-Beam Leading
Kinetic Energy.....	649.0 kip-ft (879.9 kJ)
Exit Conditions	
Exit Velocity.....	25.34 mph (40.78 km/h)
Exit Angle.....	29.5°
Final Vehicle Position.....	117.8 ft. (35.9 m) downstream
	62.1 ft. (18.9 m) Right
Vehicle Snagging.....	Minor
Vehicle Pocketing.....	None
Vehicle Stability.....	Satisfactory
Maximum Roll Angle.....	-4.7°
Maximum Pitch Angle.....	9.8°
Maximum Yaw Angle.....	13.0°

Occupant Risk	
Longitudinal OIV.....	26.6 ft/s (8.1 m/s)
Lateral OIV.....	6.9 ft/s (2.1 m/s)
Longitudinal RA.....	-10.0 g
Lateral RA.....	4.1 g
THIV.....	27.6 ft/s (8.4 m/s)
PHD.....	10.1 g
ASI.....	0.82
Test Article Deflections	
Static.....	14.3 ft. (4.4 m)
Dynamic.....	N/A
Working Width.....	18.1 ft (5.5 m)
Article Debris Field.....	105.9 ft. (32.3 m) downstream
	45.9 ft. (14.0 m) right
Vehicle Damage	
Vehicle Damage Scale.....	12-FD-4
CDC.....	12FDEW4
Maximum Intrusion.....	1.3 in. (33 mm)

3-44 (2270P)	<p>The SLED was positioned at a nominal angle of 20° with the center line of the test vehicle directed at the corner of the guardrail that is connected to the rearmost SLED yellow water filled module. The side angled impact test is to evaluate the SLED's ability to bring the vehicle to a controlled stop. This angle and intersection directed the test vehicle into the third module from the front of the system. The test was conducted using a commercially available 2012 RAM 1500 4-door pickup truck with a test inertial mass of 4,989.0 lbs. (2,263.0 kg). The test vehicle impacted the SLED at a velocity of 62.38 mph (100.39 km/h) and at an impact angle of 19.8°. The test vehicle impacted the third yellow water filled module, causing the vehicle to redirect slightly while crushing and rupturing the yellow filled module. As the vehicle continued forward the rearmost yellow water filled module was impacted and ruptured, which caused it to tear and disperse the contained water at the transition. The W-beam transition panel separated from the transition pin and allowed the vehicle to continue forward behind the crash cushion. The vehicle came to a controlled stop 117.8 ft. (35.9 m) downstream and 62.1 ft. (18.9 m) lateral from the initial point of impact. The yellow SLED modules remained tethered together but separated from the guardrail at the transition portion of the system. The steel t-pins between the module knuckles which connects directly to the internal molded in steel cables remained intact. The impacting vehicle was brought to a controlled stop, remained upright and did not exhibit vaulting throughout the impact event. The test vehicle's occupant compartment was not penetrated and there was no in cab deformation beyond allowable limits. The maximum roll and pitch angle did not exceed 75°. The SLED attached to guardrail met all the requirements of MASH Test 3-44.</p>	PASS

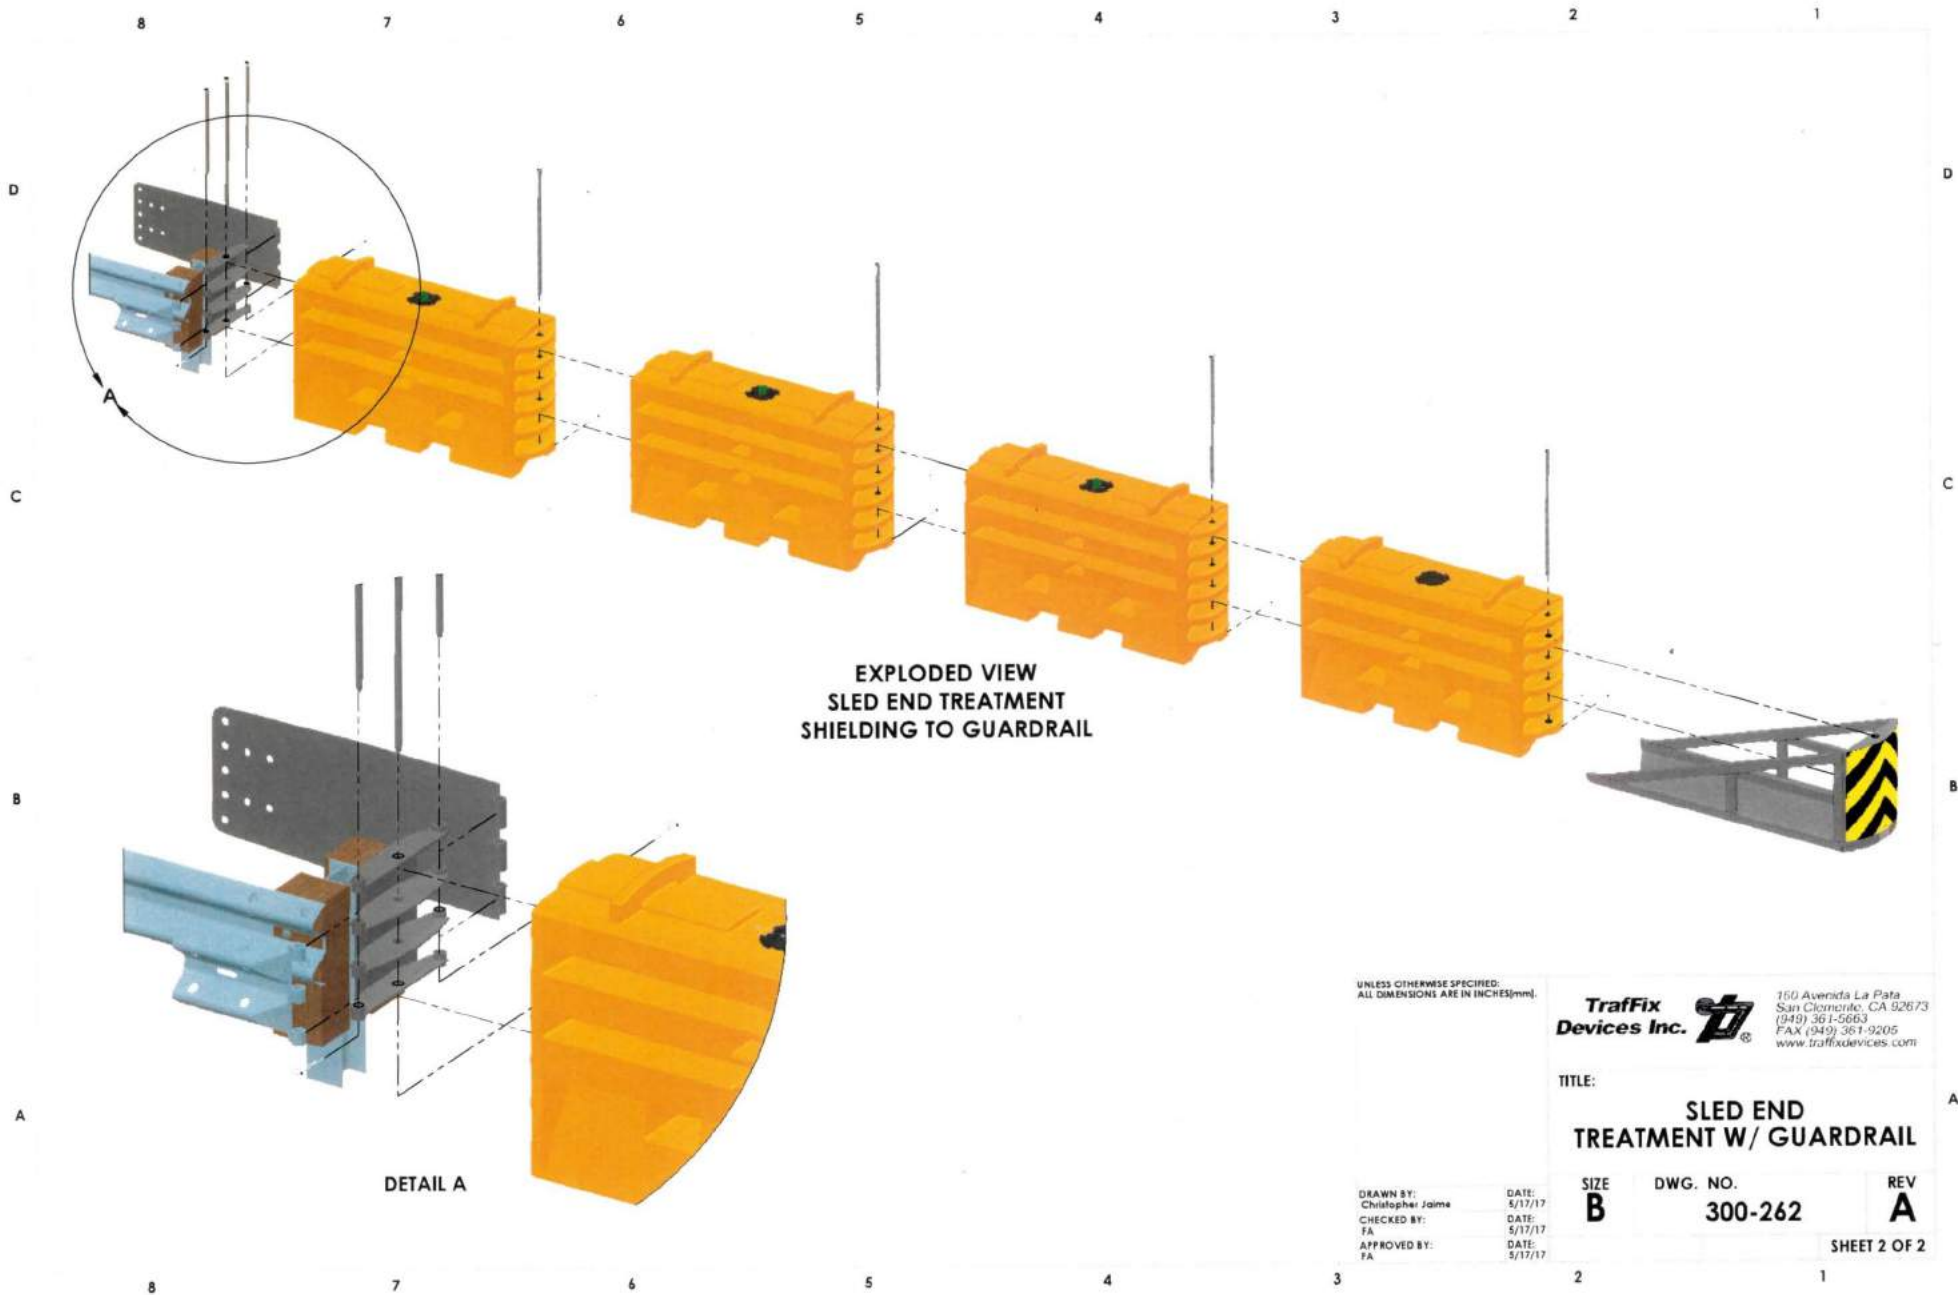
DWG. NO.
300-262

EXPLODED VIEW
SLED END TREATMENT
SHIELDING TO GUARDRAIL

TITLE:
**SLED END
TREATMENT W/ GUARDRAIL**

The SLED is a free standing, non-redirective, gating crash cushion, designed to shield the end of guardrail. The SLED does not require anchoring to the road surface and can be used on concrete, asphalt, gravel, and dirt surfaces. The SLED was tested on a dirt surface. The SLED can be used in TL-1, TL-2, and TL-3 installations to treat the end of guardrail. The SLED attached to guardrail test series was conducted at TL-3 conditions. The SLED utilizes a transition that is mechanically attached to the guardrail it is shielding. The SLED system consists of four main components: three yellow water filled modules, one yellow empty module, one Containment Impact Sled (CIS), and one transition. The SLED's overall dimensions are 25.25 ft. (7.7 m) long (pin to pin) x 27.25 in. (0.7 m) wide x 45.875 in. (1.2 m) tall. The yellow modules are manufactured from polyethylene that is UV stabilized. The SLED system consists of three water filled modules with the front empty module connected to the steel CIS. The water filled modules weigh approx. 2,000 lbs. (907 kg) when filled. The SLED's yellow water filled modules contain a fill lid, which incorporates a pop-up float water level indicator for identifying that modules are filled to the appropriate level. Permanently molded within the plastic modules are four corrosion resistant cables. The modules are designed with knuckles at the ends which contains a series of vertically aligned concentric holes that allow a steel t-pin to be inserted to connect adjacent modules together. When modules are pinned together there are a total of eleven knuckles aligned with the steel t-pin inserted. At the front of the SLED system is the steel CIS that is connected to the front yellow empty module. The CIS is designed using a steel tube frame and sheet metal construction. The front yellow empty module is connected to the CIS through the vertically aligned concentric holes in the knuckles and the t-pin connects the module and the CIS together. This is the same connection method used between the three yellow water filled modules. Bolted to the front impact face on the CIS is the directional indicator panel. The directional indicator panel is a square sheet of plastic that contains gore point directional sheeting on one side and left, or right, directional sheeting on the opposite side. This allows the user to convert the panel to the proper direction when installing the SLED. The directional indicator panel contours to the curved shape on the front impact face on the CIS and is secured by six bolts. Other directional sheeting and markings are available. The SLED is attached to the guardrail using a w-beam transition panel and a standard panel attached to the w-beam. The SLED transition is made of three components: one steel transition frame, one standard transition panel, and one w-beam transition panel. The transition frame is positively connected to the rear most water filled module through the vertically aligned concentric holes in the knuckles using a steel drop pin. This is the same connection method used between the yellow water filled modules and between the CIS and the front yellow empty module. The transition panels are pinned to the transition frame using outboard alignment pins designed into the transition frame. The transition panel is attached to the guardrail panel using eight guardrail bolts. The standard transition panel and w-beam transition panels are also connected to the w-beam using one guardrail post bolt and two wooden blockouts.

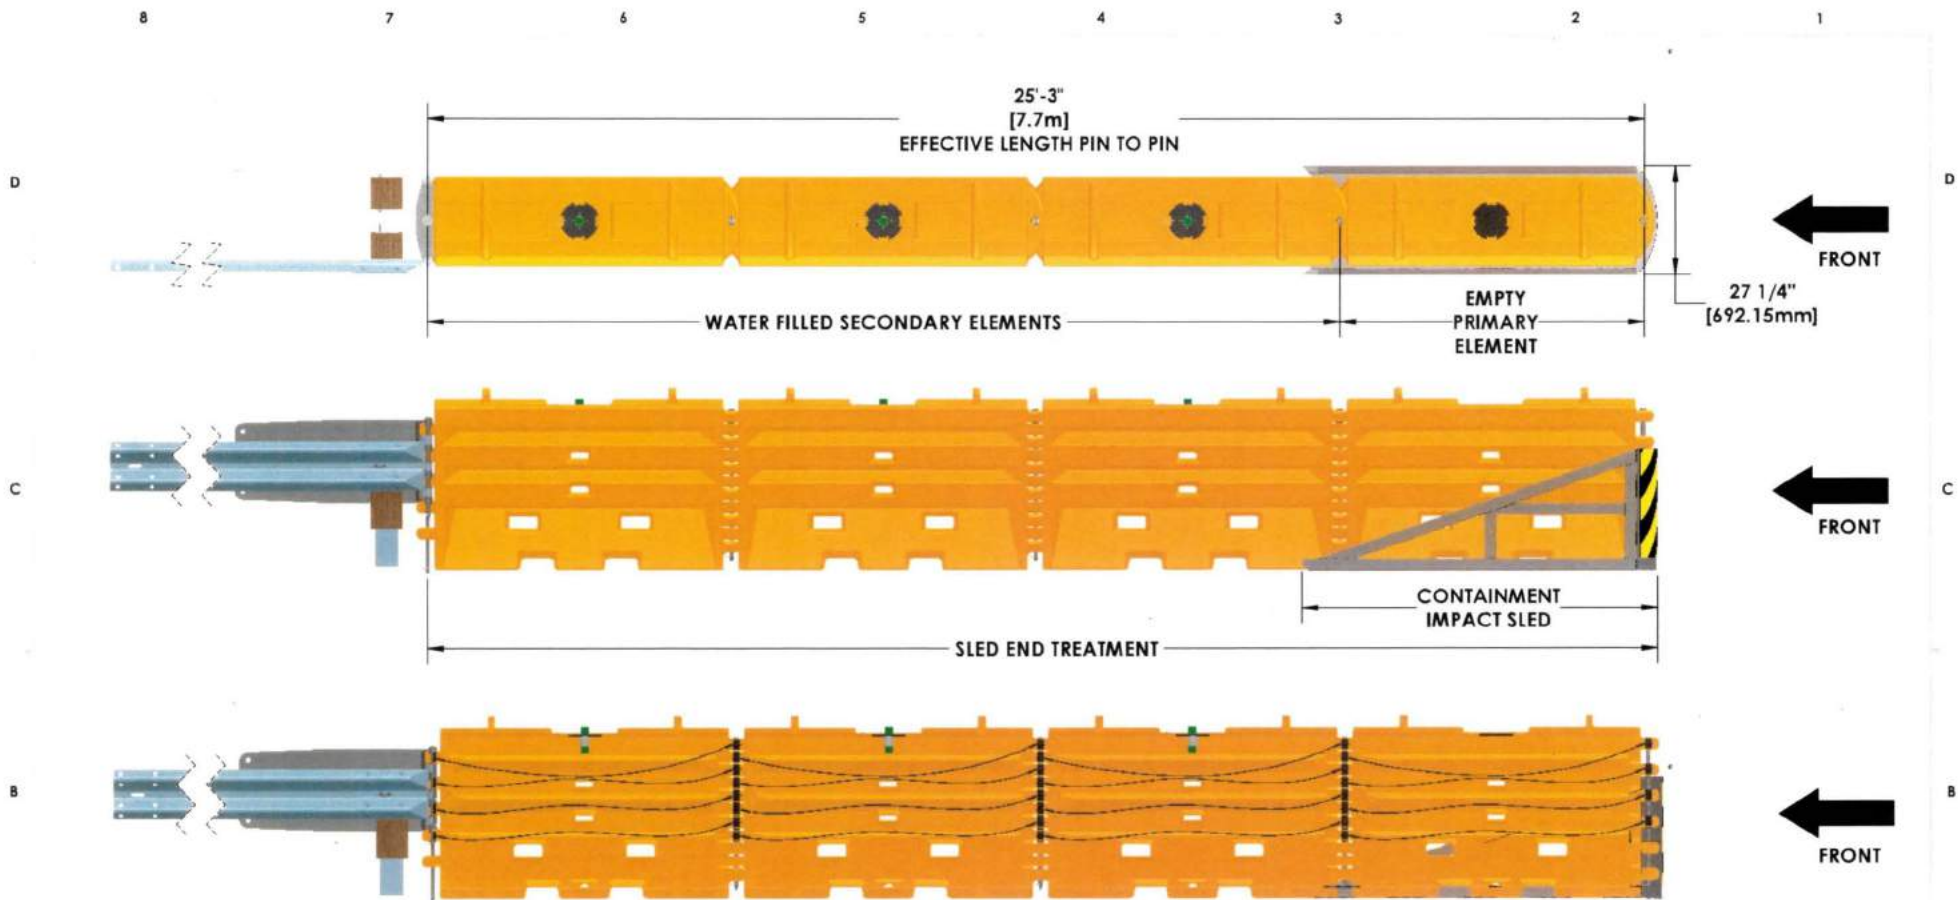
SIZE **B** DWG. NO. **300-262** REV **A**

CUT AWAY SLED END TREATMENT
ALL SECTIONS CONTAIN INTERNAL MOLDED-IN CABLES

TITLE:
**SLED END
TREATMENT W/ GUARDRAIL**

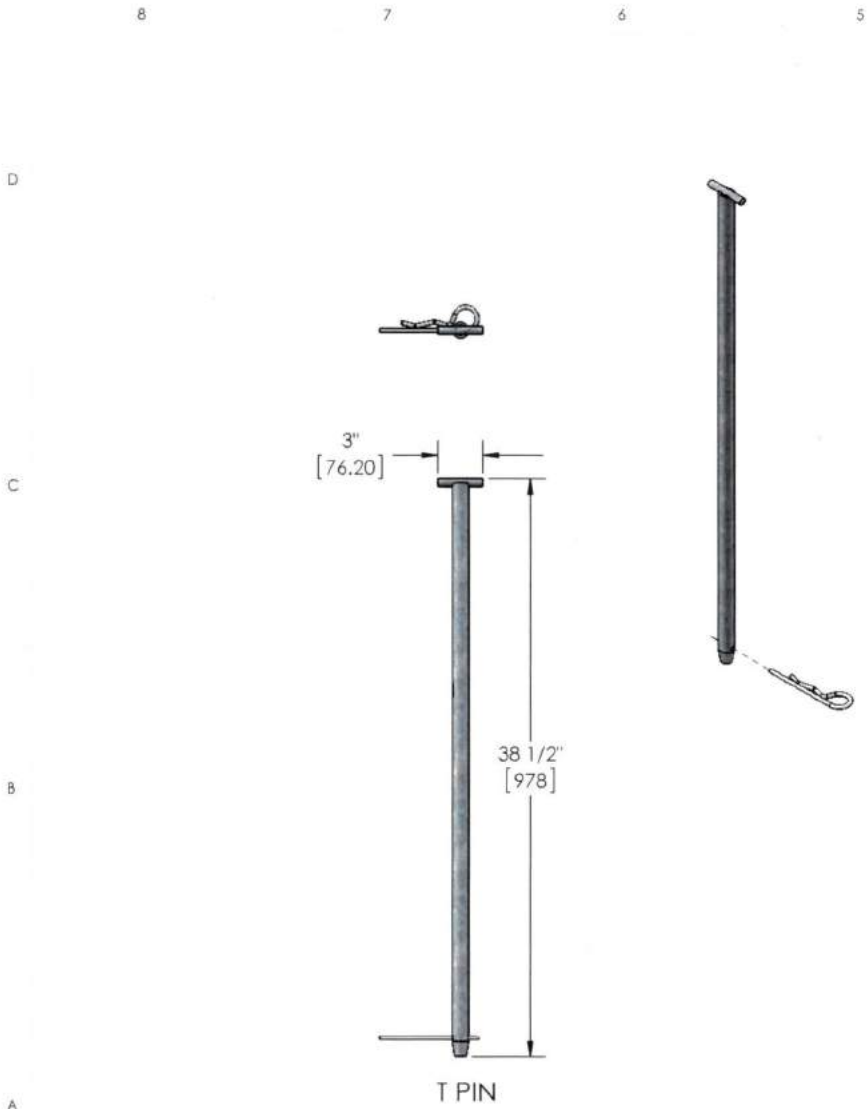
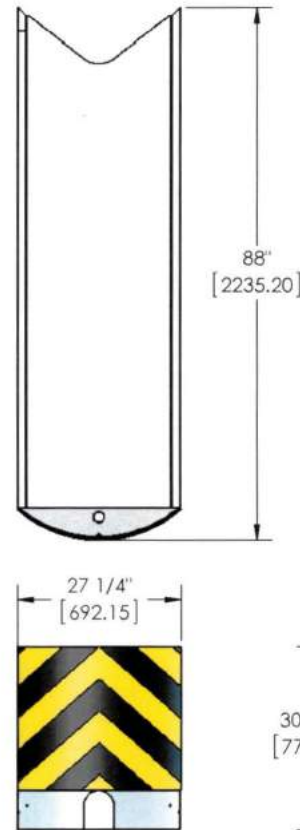
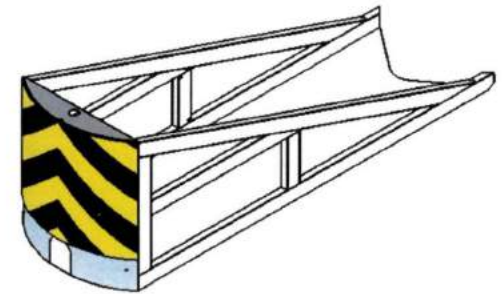
SIZE **B** DWG. NO. **300-106** REV **H**

FRONT STEEL CAP

TITLE:
**SLED END TREATMENT
 HARDWARE**

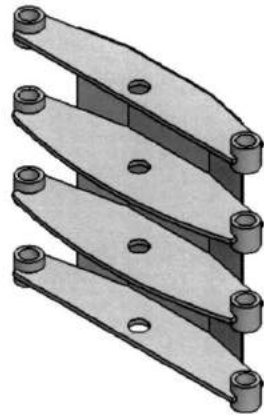
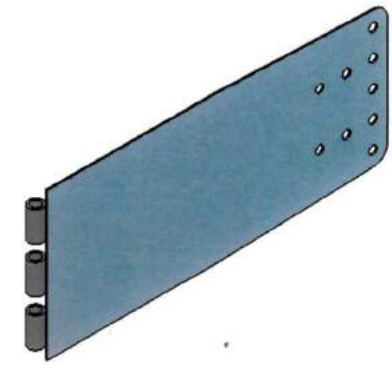
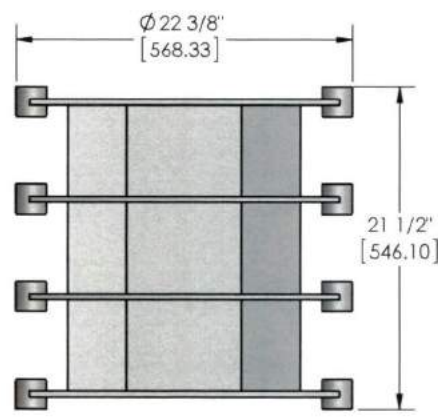
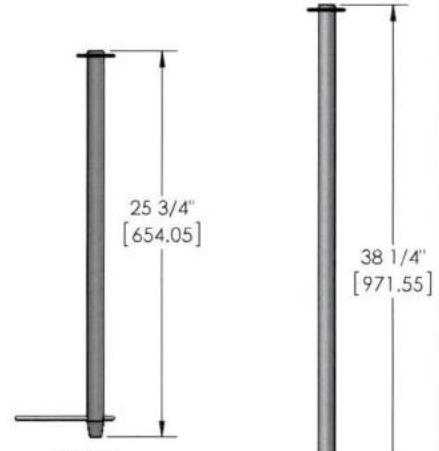
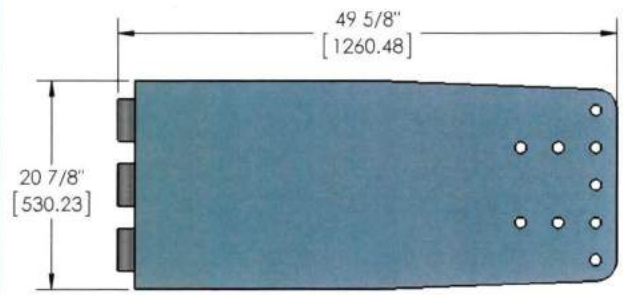
SIZE **B** DWG. NO. **300-106** REV **H**

SLED END TREATMENT TRANSITION FRAME

SHORT OUTSIDE TRANSITION PIN W/ KEEPER PIN

LONG CENTER TRANSITION PIN W/ KEEPER PIN

SLED END TREATMENT TRANSITION PANEL

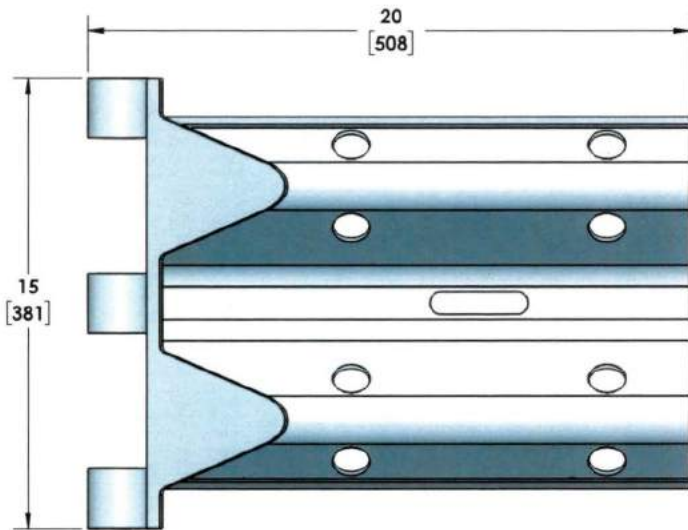
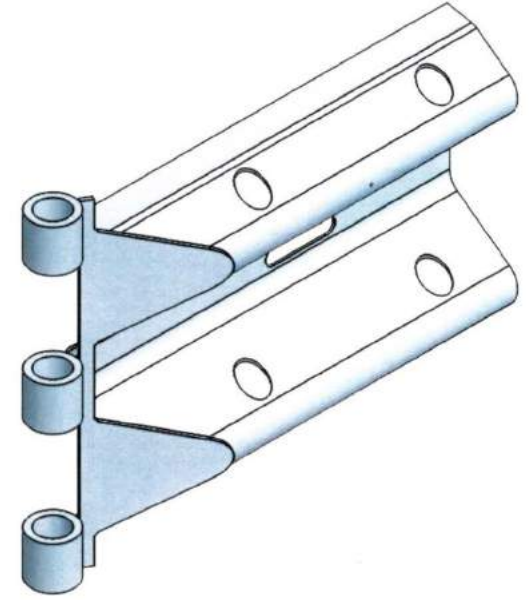
DWG. NO.
300-263

**W-Beam Guardrail
 Transition Panel**

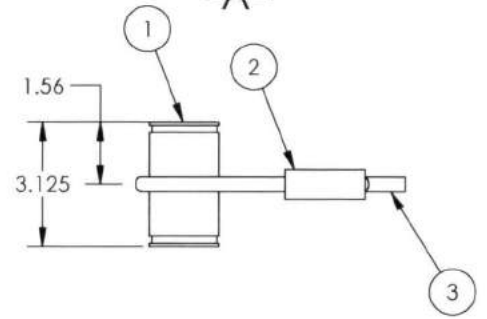
SIZE B	DWG. NO. 323	REV A
------------------	------------------------	-----------------

CABLE SPEC
 3/8" DIA WIRE ROPE
 CORROSION RESISTANT

TITLE: **WATER WALL WIRE ROPE**

ITEM NO.	DESCRIPTION	QTY
1	BUSHING	2
2	SWAGE	2
3	CABLE	1
